CONNECTICUT RIVER BASIN
HARRISVILLE, NEW HAMPSHIRE

CHESHAM POND DAM
NH 00063

PHASE I INSPECTION REPORT
NATIONAL DAM INSPECTION PROGRAM

MARCH 1980

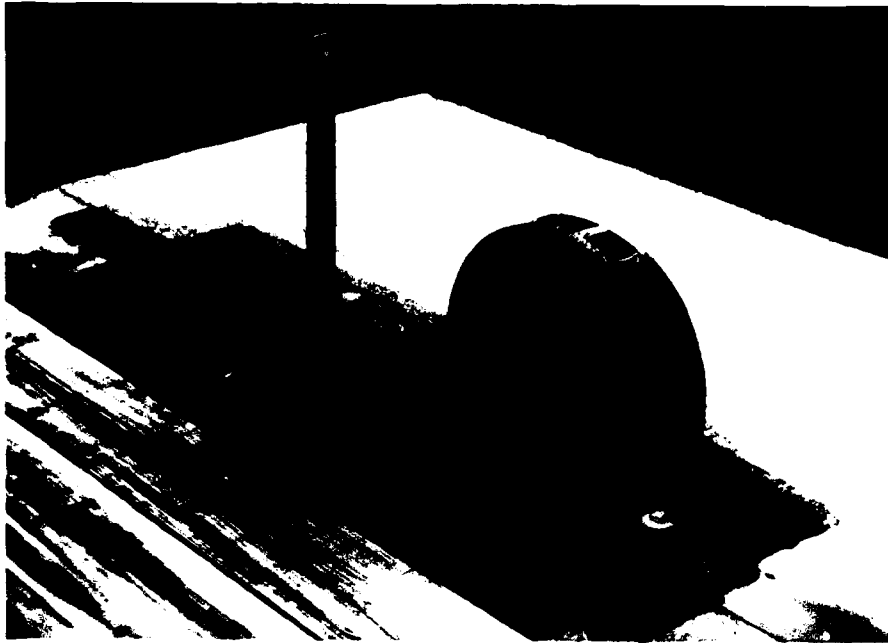
Throughout the year, the dam is visited on a weekly basis by a maintenance staff member of the NHWRB. A weekly log is kept on conditions at the dam site. The gate was not operated during the inspection; however, the mechanism appeared to be in satisfactory condition but has surface rust.

September 13, 1979
Figure 8 - Looking at the control mechanism for the
low-level gated outlet.

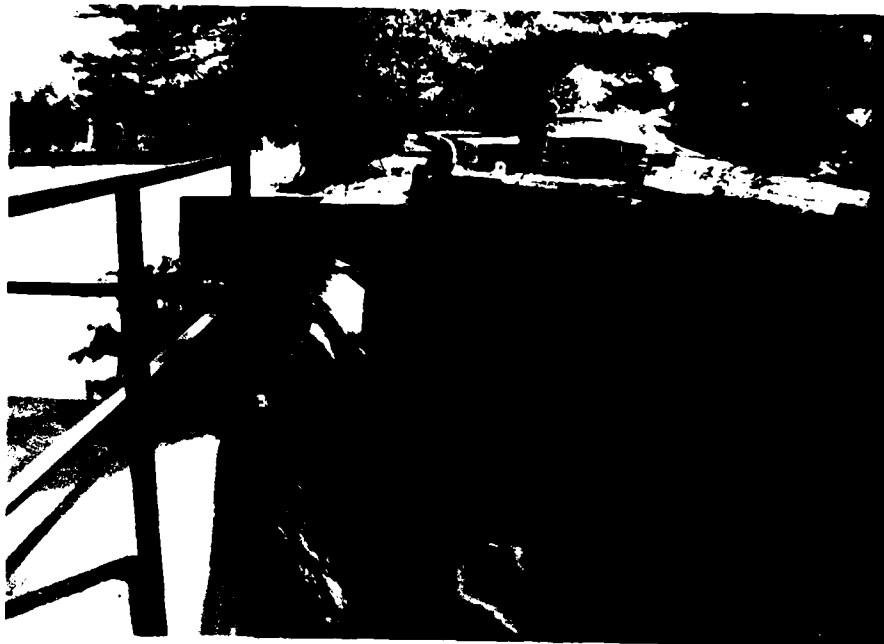
September 13, 1979
Figure 2 - Looking southeast across crest of the dam.
